# Investigation of Failures of White-Coat Plaster

United States Department of Commerce  
National Bureau of Standards  
Building Materials and Structures Report 121

Building Materials and Structures Report 121

Issued February 1, 1951

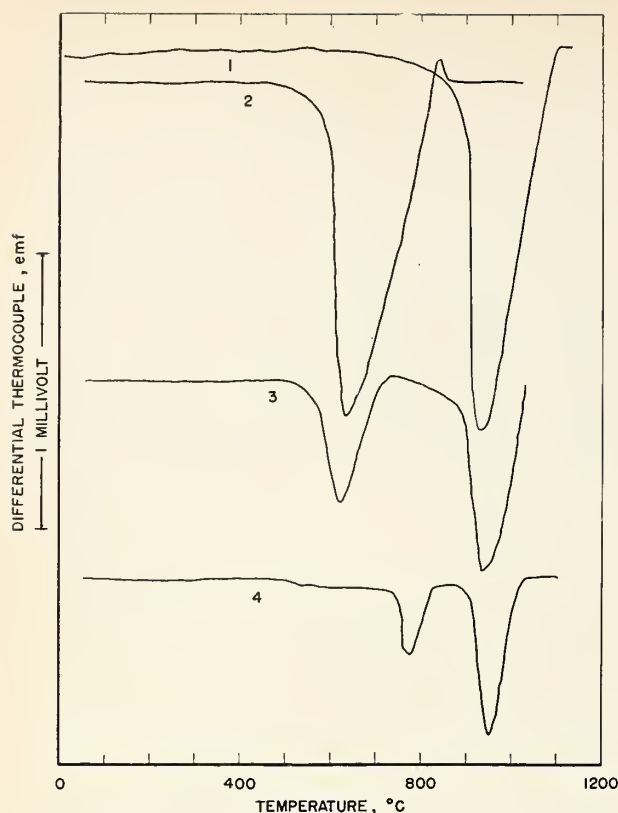
The existence of the superheating of magnesium carbonate is demonstrated in figure 14 where its heating curve (2) shows a (nonequilibrium) decomposition temperature of  $635^\circ \text{C}$  ( $1,175^\circ \text{F}$ ) for magnesite ( $\text{MgCO}_3$ ). The temperature is changed only slightly by the presence of calcite. The heating curve of an equimolar mixture (curve 3) shows decomposition temperatures of  $625^\circ \text{C}$  ( $1,157^\circ \text{F}$ ) and  $935^\circ \text{C}$  ( $1,715^\circ \text{F}$ ) for the magnesite and calcite, respectively.

The fourth heating curve in figure 14 demonstrates the increase in the decomposition temperature of dolomite over that of magnesite. In this test, dolomite (NBS Standard Sample 88) was decomposed in two steps, showing decomposition temperatures of  $778^\circ \text{C}$  ( $1,432^\circ \text{F}$ ) and  $935^\circ \text{C}$  ( $1,715^\circ \text{F}$ ), respectively.

FIGURE 14. Four differential heating curves showing the dynamic decomposition temperatures of (1) calcite, (2) magnesite, (3) equimolar mixture of calcite and magnesite, and (4) dolomite.

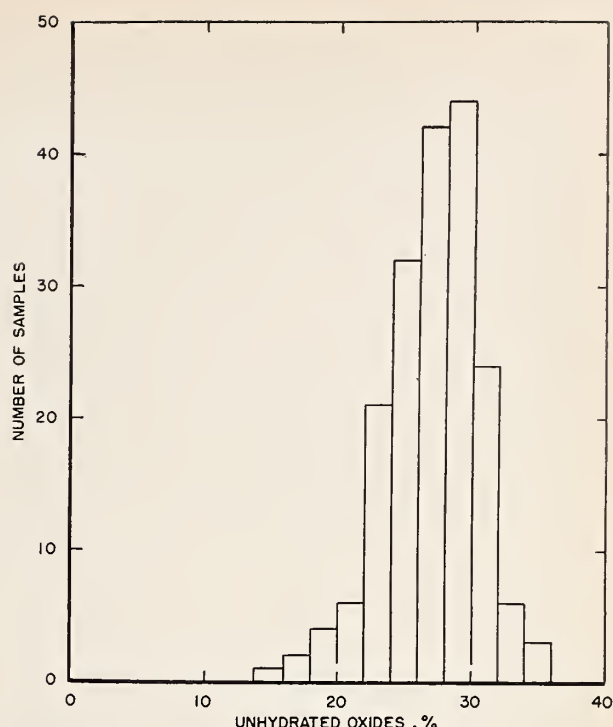
FIGURE 15. Distribution of the percentage of unhydrated oxides in 185 (N) samples of regularly hydrated dolomitic lime, submitted to the Bureau for test from 1923 to 1940, showing that the average amount ( $\bar{X}$ ) was 26.98 percent with a standard deviation ( $\sigma$ ) of 3.04 percent.

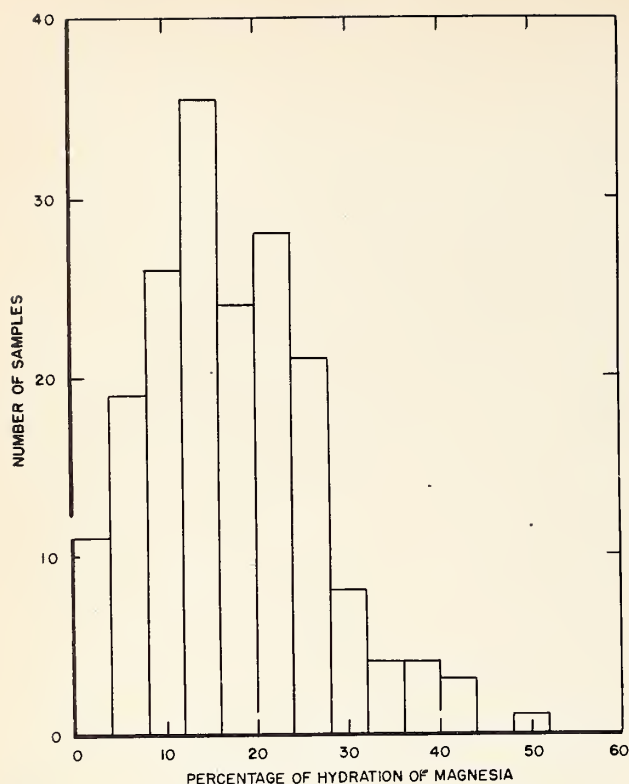
FIGURE 16. Distribution of the percentage of hydration of the magnesia in 185 ( $N$ ) samples of regularly hydrated dolomitic lime, submitted to the Bureau for test from 1923 to 1940, showing that the average amount ( $\bar{X}$ ) was 17.29 percent with a standard deviation ( $\sigma$ ) of 8.40 percent.

centage of unhydrated oxides for these 185 samples of regularly hydrated dolomitic lime; figure 16, the distribution of the percentage of the total magnesia that was hydrated. In this figure,  $N$  represents the number of samples;  $\bar{X}$ , the average percentage of unhydrated oxides (actually  $\text{MgO}$ ); and  $\sigma$ , the standard deviation calculated from the grouped data.

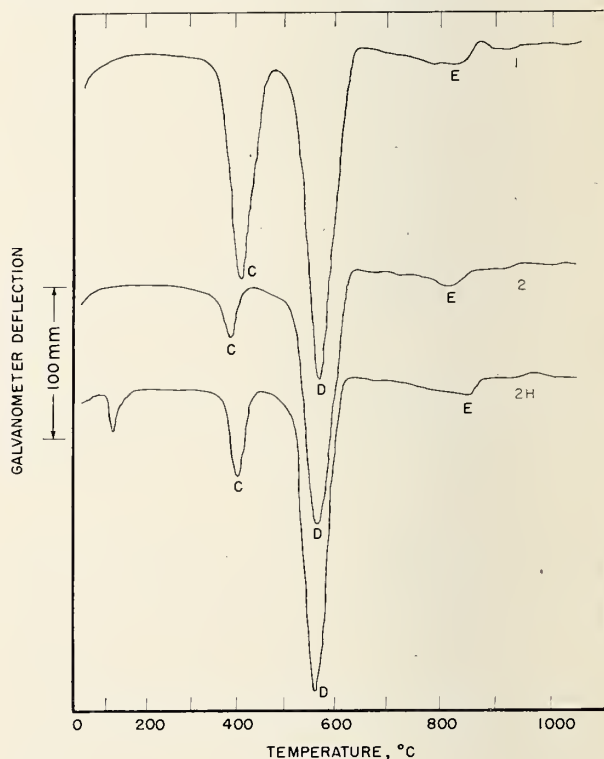
FIGURE 17. Differential heating curves of a completely hydrated dolomitic lime (1) in contrast to a regularly hydrated dolomitic lime (2) and a putty made therefrom (2H).

The small increase in the amount of  $\text{Mg}(\text{OH})_2$  caused by hydration of the lime as a putty can be observed by comparing the relative sizes of the characteristic deflections, C, of  $\text{Mg}(\text{OH})_2$  at  $400^\circ\text{C}$  and, D, of  $\text{Ca}(\text{OH})_2$  at  $580^\circ\text{C}$  in these curves (2 and 2H) and in curve 1. Small quantities of  $\text{CaCO}_3$  are indicated by E.

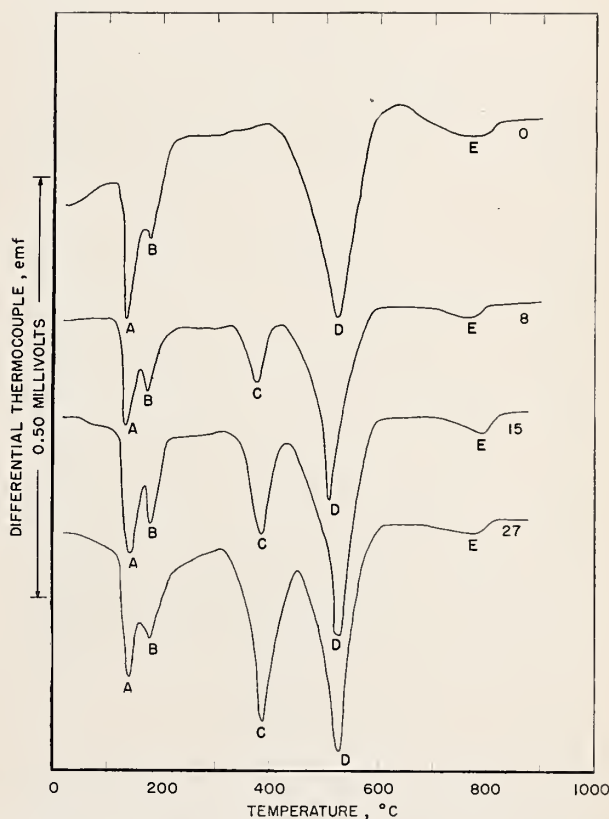
FIGURE 18. Differential heating curves of four mixtures of  $\text{CaSO}_4 \cdot 2\text{H}_2\text{O}$ ,  $\text{Mg}(\text{OH})_2$ ,  $\text{MgO}$ ,  $\text{Ca}(\text{OH})_2$ , and  $\text{CaCO}_3$ .

The percentage of  $\text{Mg}(\text{OH})_2$  is indicated beside each curve. Five regions of heat absorption, in the order of increasing temperature, are A, dehydration of gypsum to hemihydrate, B, dehydration of hemihydrate, C, dehydration of magnesium hydroxide, D, dehydration of calcium hydroxide, and E, decomposition of calcium carbonate.

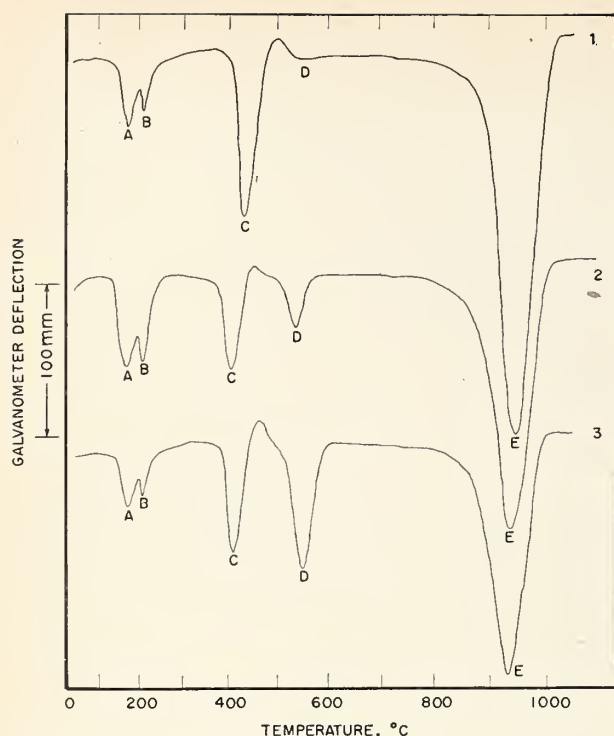
FIGURE 19. Differential heating curves of three samples of white-coat plaster that had failed by expansion.

The five major regions of heat absorption, in the order of increasing temperature, are A, dehydration of gypsum to hemihydrate, B, dehydration of hemihydrate, C, dehydration of magnesium hydroxide, D, dehydration of calcium hydroxide, and E, decomposition of calcium carbonate.

The five major heat effects are shown on the heating curves of samples from three plaster failures, figure 19. Particularly to be noted is the almost complete absence in curve 1 of the deflection characteristic of the dehydration of  $\text{Ca}(\text{OH})_2$ . This sample, in which almost complete carbonation of  $\text{Ca}(\text{OH})_2$  had occurred, contained no detectable magnesium carbonate. The composition of the plasters represented by the curves in figure 19 can be found in table 3, where samples numbered 42, 32, and 6 correspond to curves 1, 2, and 3, respectively. The areas of the magnesium-hydroxide deflections on the heating curves are roughly proportional to the calculated  $\text{Mg}(\text{OH})_2$  in these plasters. It is apparent that the assumptions made in calculating the compound composition of the plasters must be approximately correct.

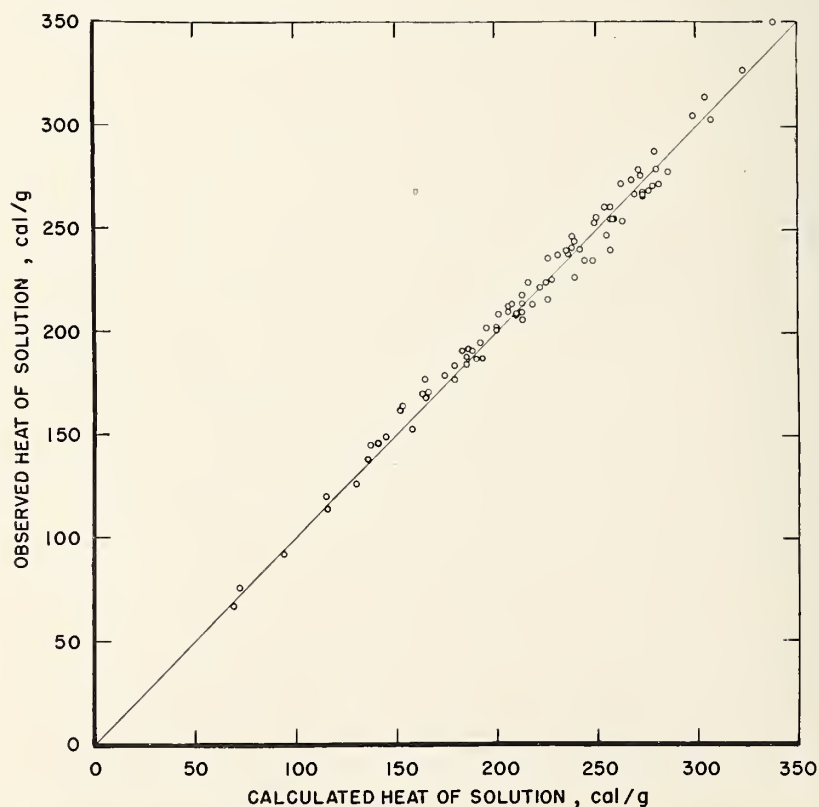
FIGURE 20. Scatter diagram of 88 pairs of calculated and observed heats of solution of samples of failed white-coat plaster.

Figure 20 is a scatter diagram of the 88 pairs of observed and calculated heats of solution. The line best representing these data, determined by the method of least squares, is  $Ob = 5.4 + 0.980 C$ , regarding the calculated values as the independent variable, and  $Ob = 2.6 + 0.993 C$ , regarding the observed heats of solution as the independent variable. In these equations  $Ob$  and  $C$  represent the observed and calculated values, respectively. In figure 20 is shown only the line representing equality of the calculated and observed values. The two lines representing the equations determined by the method of least squares are not shown in figure 20, because they would be so close to the line plotted that the paths of the three separate lines could scarcely be followed and the figure would be confusing.

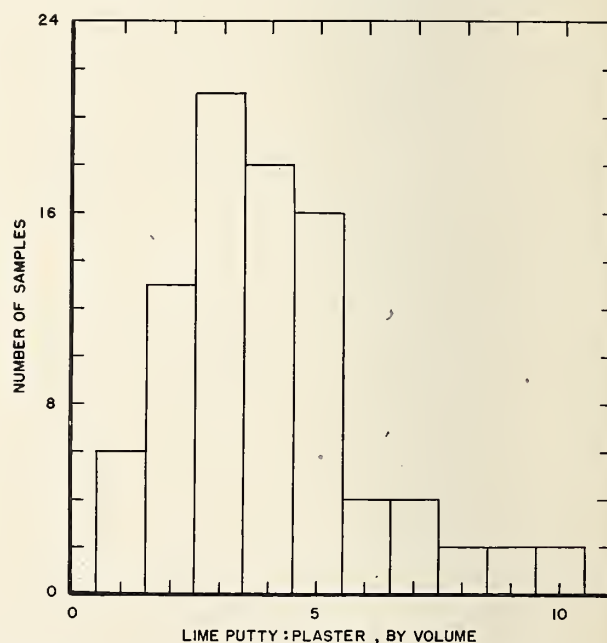
This formula was used in obtaining the values recorded in column 21 of table 3. Plaster failures from which these samples were taken occurred with ratios of lime putty to CaSO<sub>4</sub>·½H<sub>2</sub>O as low as 0.8 and as high as 9.8. Figure 21 is a distribution diagram of the ratios of lime putty to CaSO<sub>4</sub>·½H<sub>2</sub>O (by volume) for the 88 samples. The average ratio, taken from the grouped data, was 4.0, and 90 percent of the samples were scattered more or less symmetrically about that figure. Only the samples with ratios of 7.0 and higher (8 in all) appear to fall out of that distribution.

FIGURE 21. Distribution diagram of the ratios (by volume) of lime putty to gaging plaster (CaSO<sub>4</sub>·½H<sub>2</sub>O) for 88 (N) samples of white coat.

The average ratio ( $\bar{x}$ ) is 4.0, and the standard deviation ( $\sigma$ ) is 2.0.

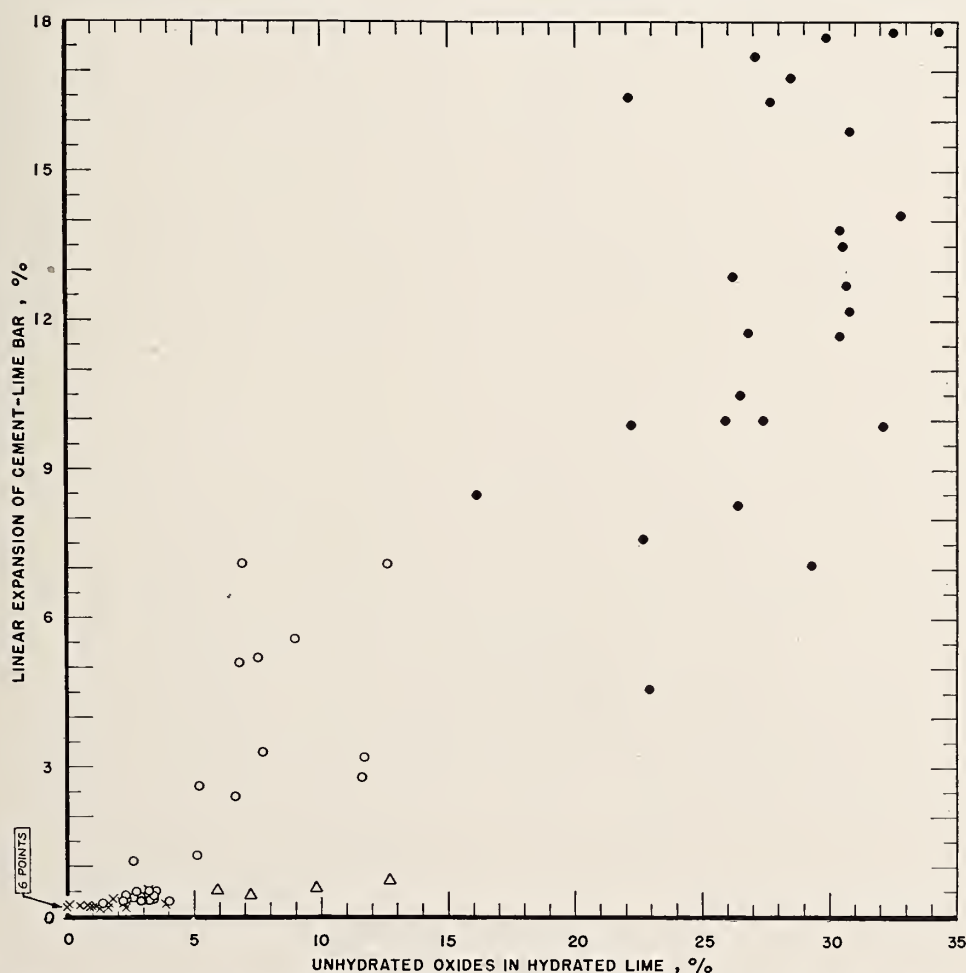
Figure 25 shows the relations of the linear expansions of some autoclaved cement-lime bars to the unhydrated oxides contents of the limes used therein. Note the high expansivity of those limes containing a high percentage of unhydrated oxides, especially of the regularly hydrated dolomitic limes—those limes that have caused and are causing such extensive white-coat failures.

FIGURE 25. Linear expansion of cement-lime bars prepared with hydrated limes containing various amounts of unhydrated oxides, in the proportion of 1 cement to 1 lime (by weight), and subsequently autoclaved for 3 hr at a gage pressure of 295 lb/in<sup>2</sup>.

X, High-calcium; ●, regularly hydrated dolomitic; ○, highly hydrated dolomitic; Δ, magnesian.

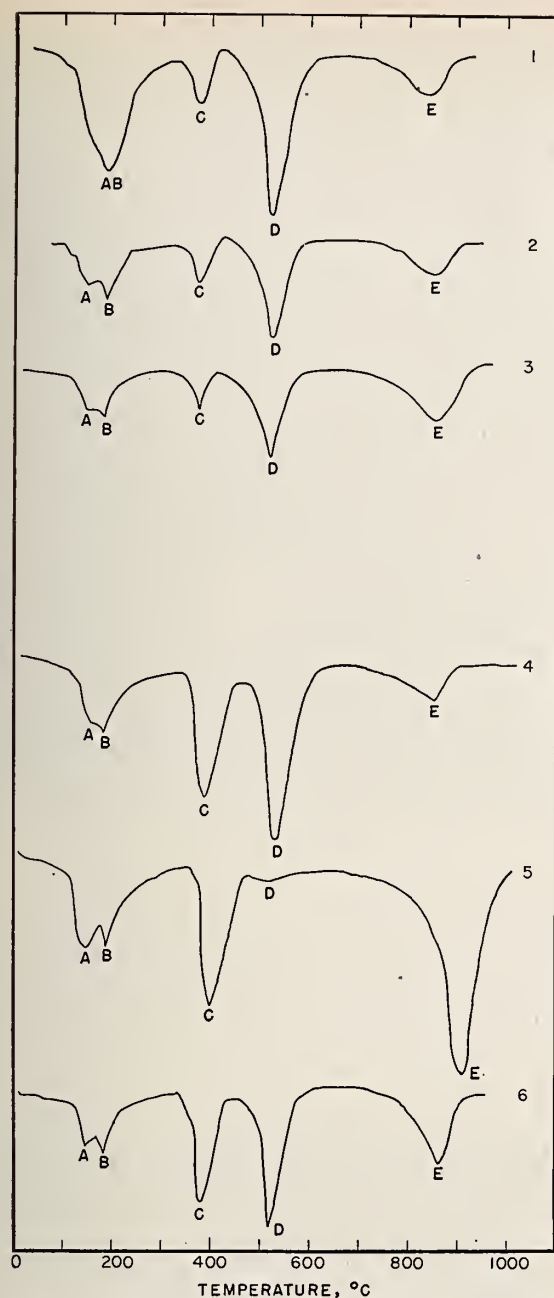
Figure 26 shows the heating curves of the six samples of freshly applied plaster. The samples bear the same numbers in the figure as in table 7. Note that the heat effect corresponding to the decomposition of  $Mg(OH)_2$  is distinctly larger for samples 4, 5, and 6, those containing highly hydrated dolomitic limes, than for samples 1, 2, and 3 in which regularly hydrated dolomitic limes were used. The reader's attention is invited to the fact that in the heating curves of these freshly applied plasters, the two separate breaks for the decomposition of gypsum and of hemihydrate are less well developed than in the curves for the older failed samples shown in figure 19.

FIGURE 26. Differential heating curves of six freshly applied white coats.

The chemical analyses are given in table 7. The five major regions of heat absorption in the order of increasing temperature are A, dehydration of gypsum, B, dehydration of hemihydrate, C, dehydration of magnesium hydroxide, D, dehydration of calcium hydroxide, and E, decomposition of calcium carbonate.
